CALIFORNIA DIVISION OF MINES AND GEOLOGY

FAULT EVALUATION REPORT FER-128

Unnamed fault along east side of Lake Berryessa.

Lake Berryessa 7.5-minute quadrangle, Napa County (figure 1).

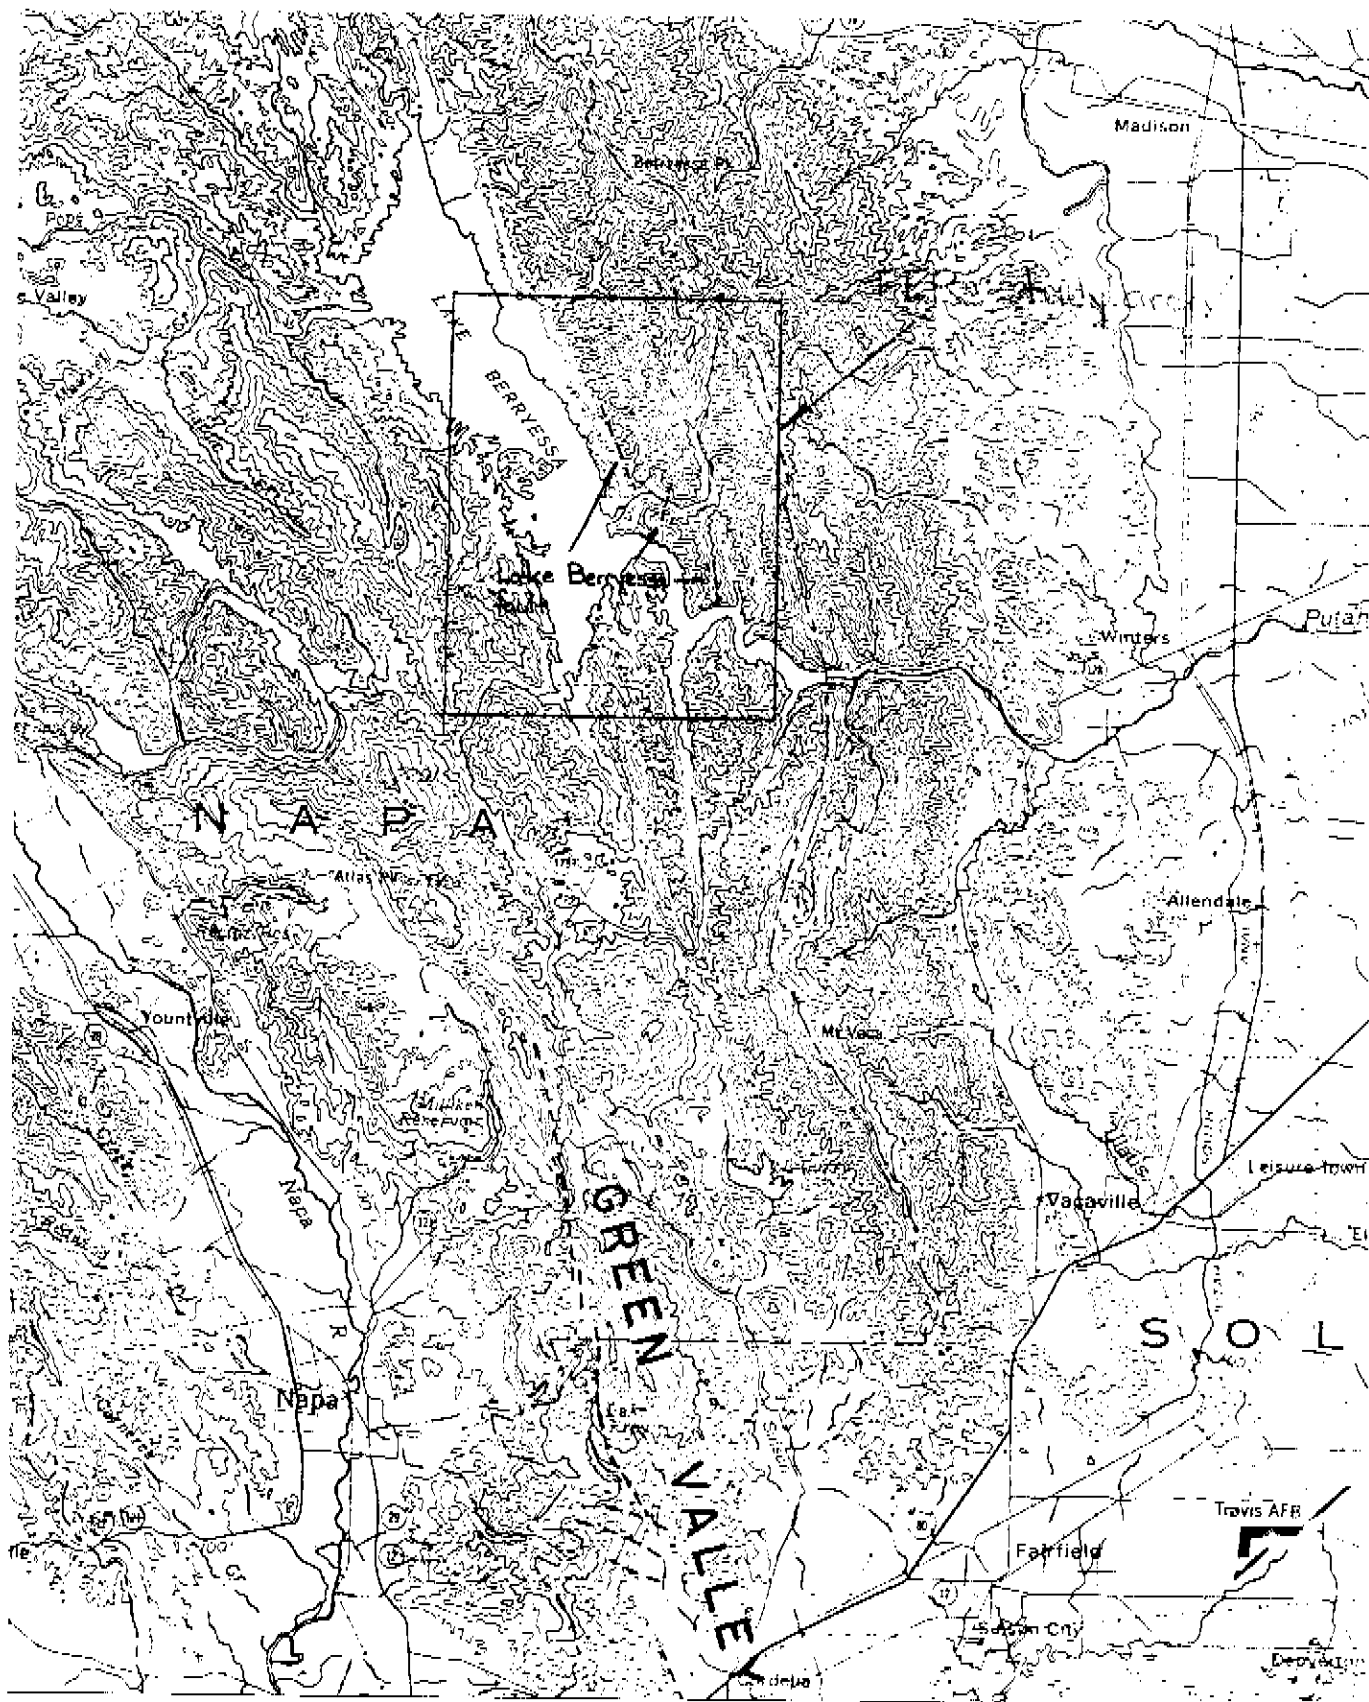
Figure 1 (to FER-128). Location of "Lake Berryessa fault" zone evaluated in FER-128.
